Tennessee Valley Property Inspections

Property Inspection Report

1234 Main Street, Anytown, TN
Inspection prepared for: Billy Bob & Eula May Jones
Date of Inspection: 1/9/2017 Time: 0900 Size: 4900sf
Weather: 30 degrees. Sunny
Home faces the east
Also inspected by Matthew Fox, Lic #1576

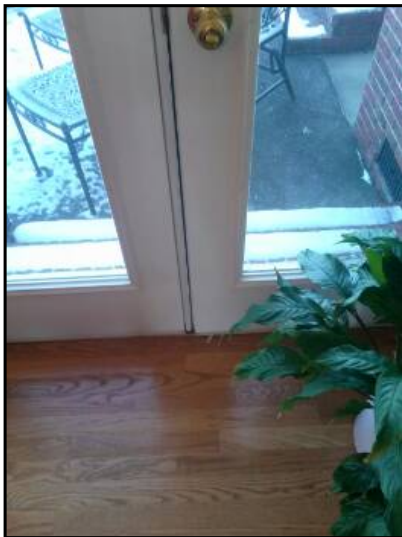
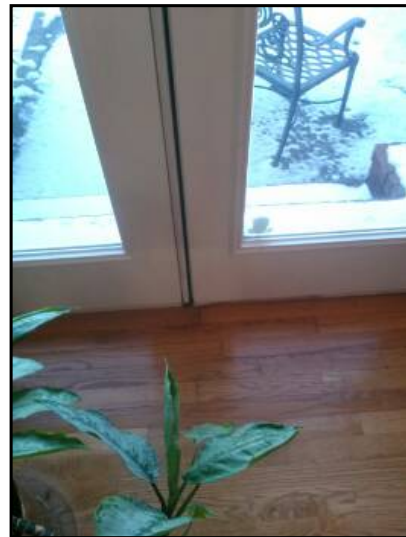
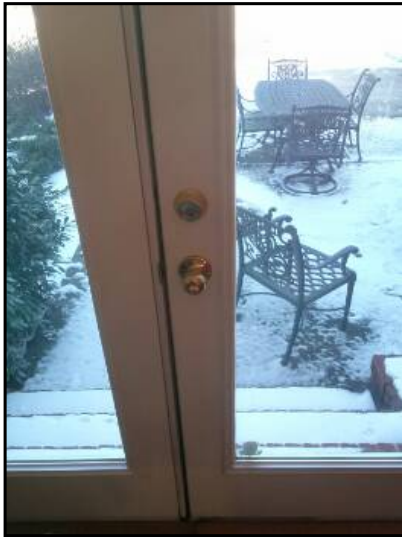
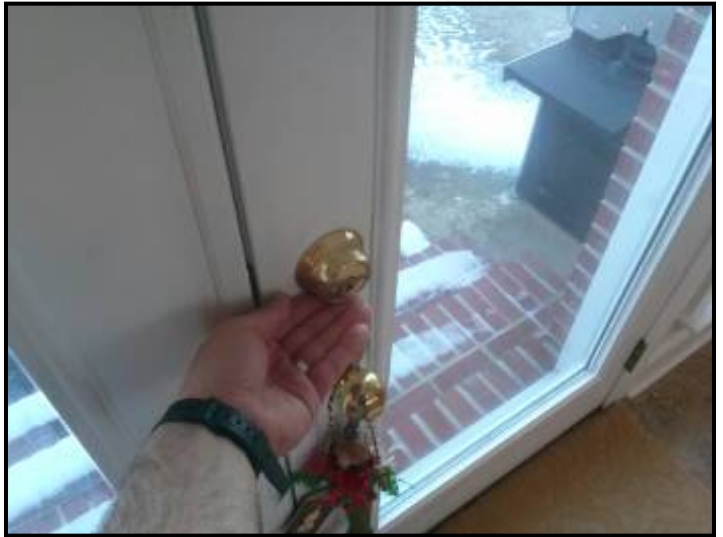
4. Doors

Observations:
 • Some interior doors were binding at frames.
 • Pedestrian egress doors had keyed interior deadbolt. These doors should require no special skill, tool, or knowledge to operate.

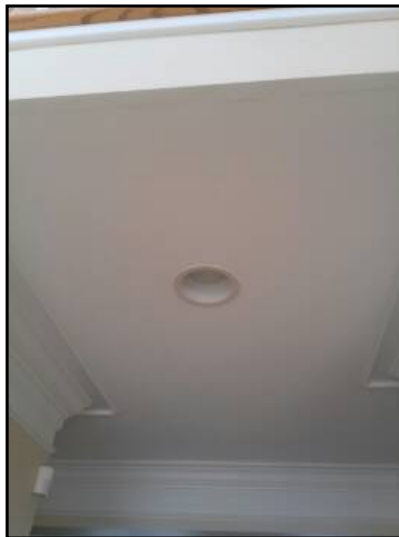
5. Electrical

- Confirm function of all fixtures not functioning at the time of inspection.

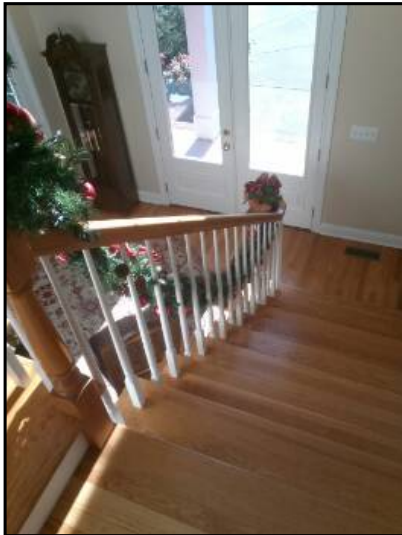
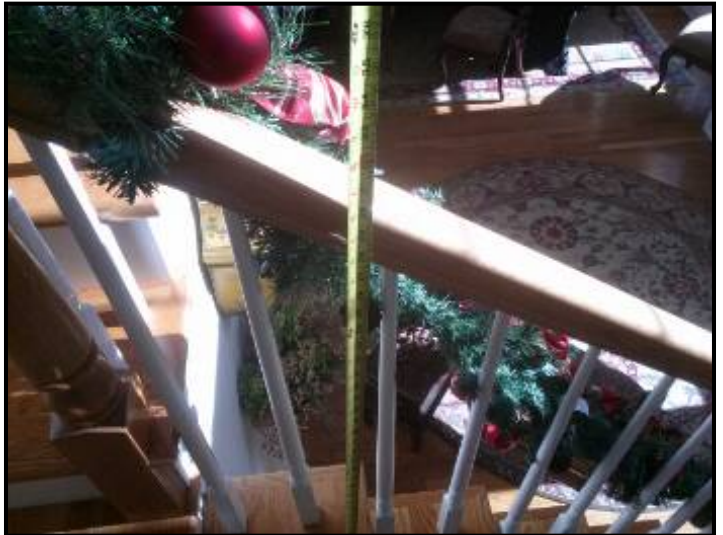
7. Stairs & Handrail

- Railing was loose at the interior stairs.
- Railing was not installed to modern building standards.

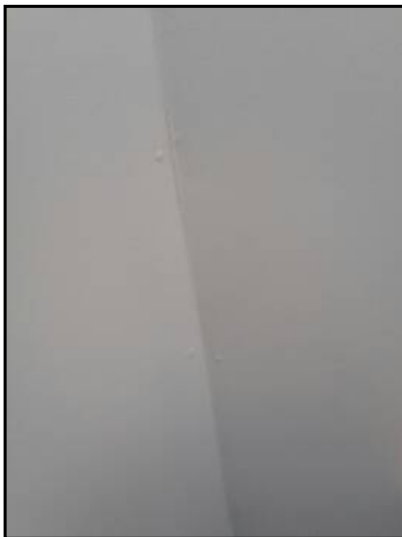
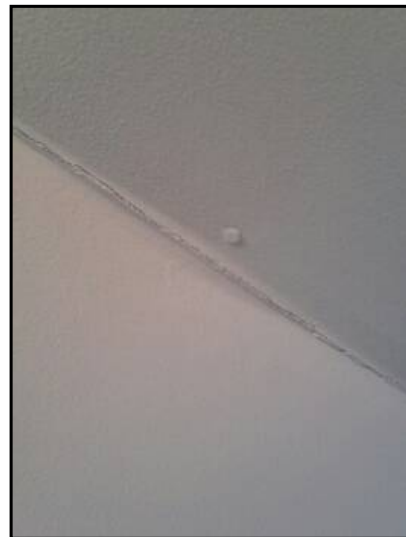
8. Ceiling Condition

- Nail pops and drywall tape separation noted at bonus room upstairs

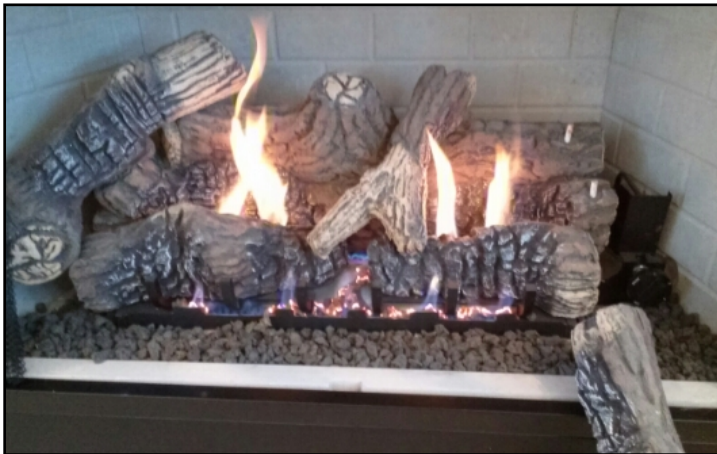
Den

- The room contains a vent free type of fireplace. It should not be operated for more than 2-4 hours at a time because of the inherent CO poisoning possibility.

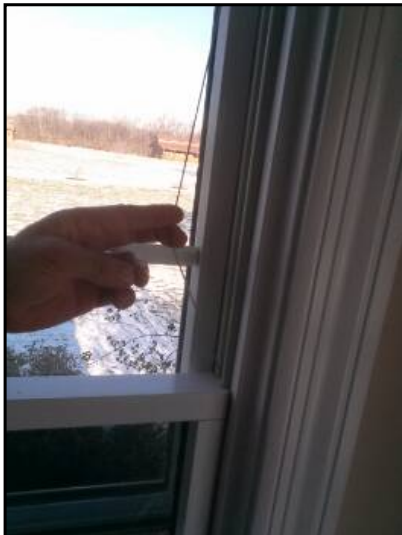
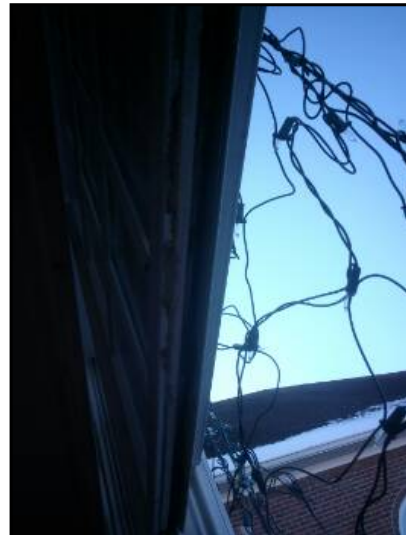
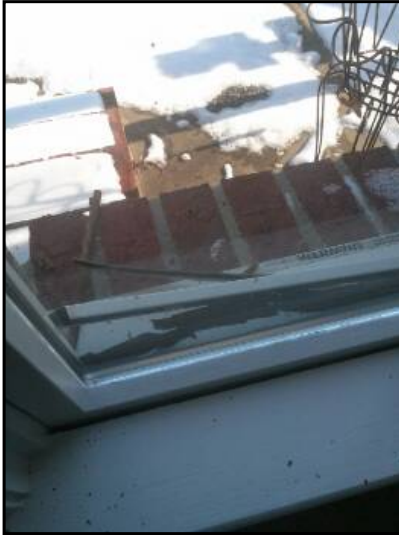
11. Window Condition

- Some window pulleys were sticking. It is possible that this will cease with window use.
- Rot was noted at the base of the some of the lower window sashes in Florida room

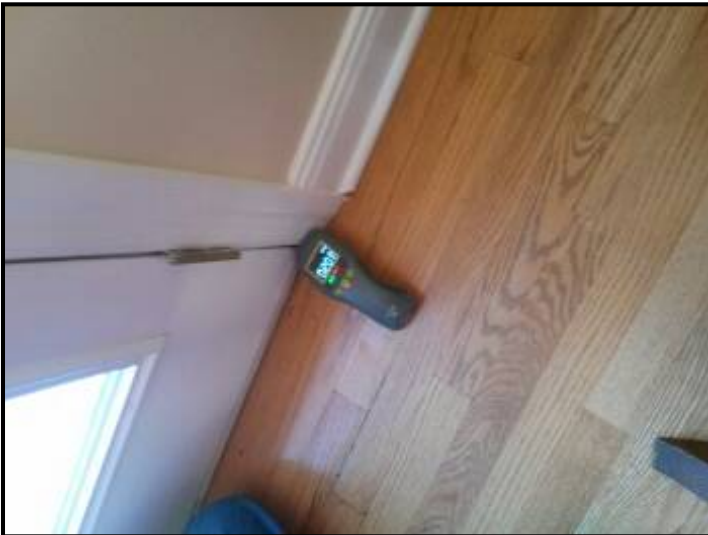
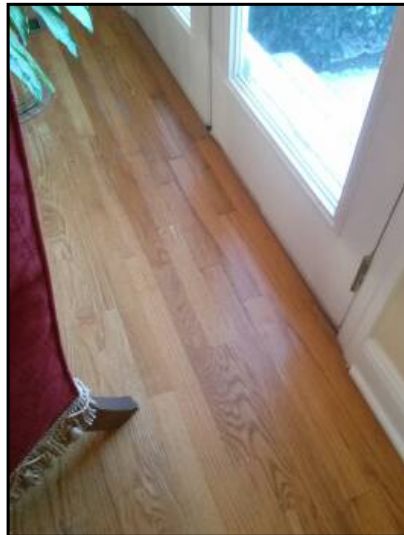
12. Floor Condition

- Moisture intrusion noted at southern French door in library.

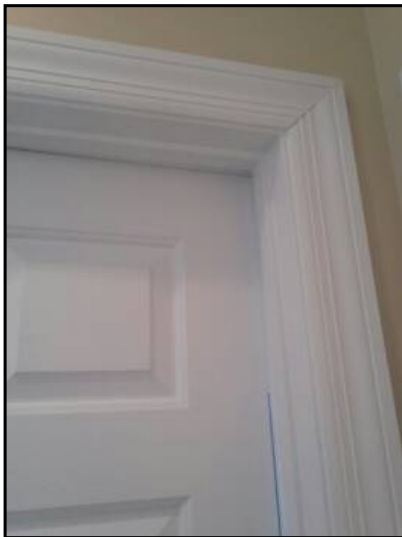
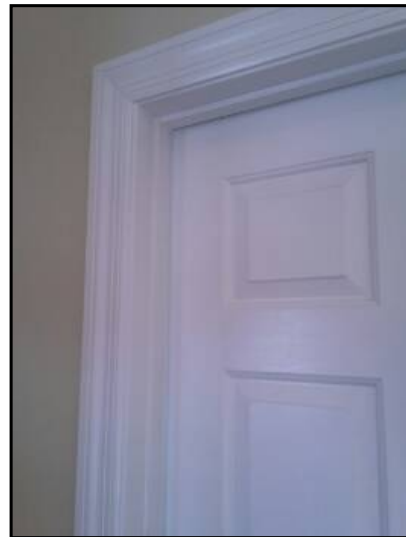
4. Doors

• Door were binding in frame upstairs.

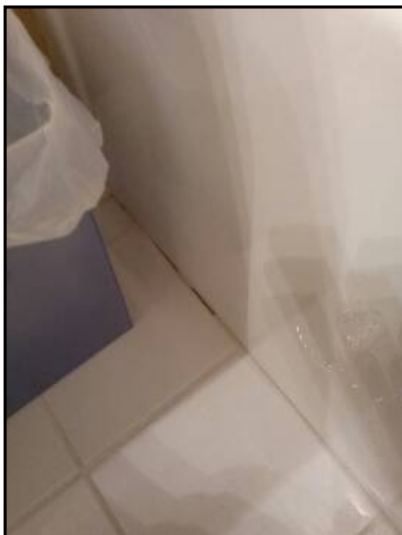
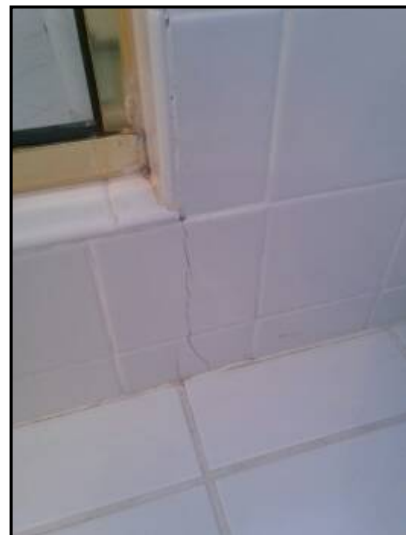
7. Floor Condition

Materials: Carpet is noted. • Ceramic tile is noted.
 Observations:
 • Cracking noted in ceramic tiles in area of master tub/bath junction
 • **Seal base of tub at flooring junction north upstairs**

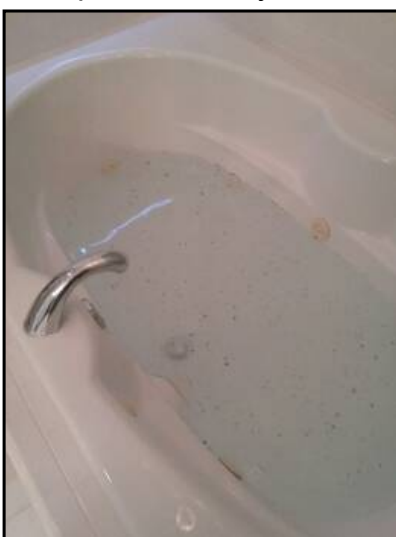
10. Bath Tubs

- Tub
- Whirlpool
- Debris was ejected from the jets during operation, recommend having circulation system professionally cleaned prior to use.

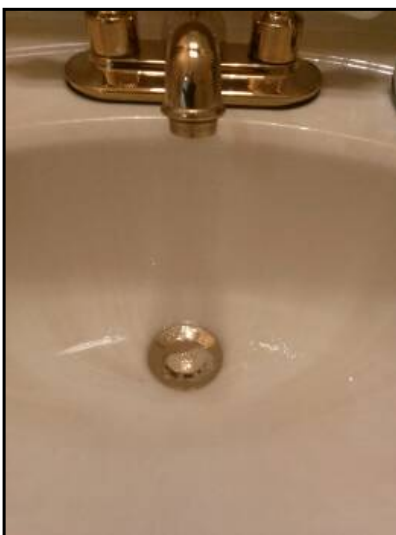
11. Sinks

- Stopper is missing/inoperable in half bath

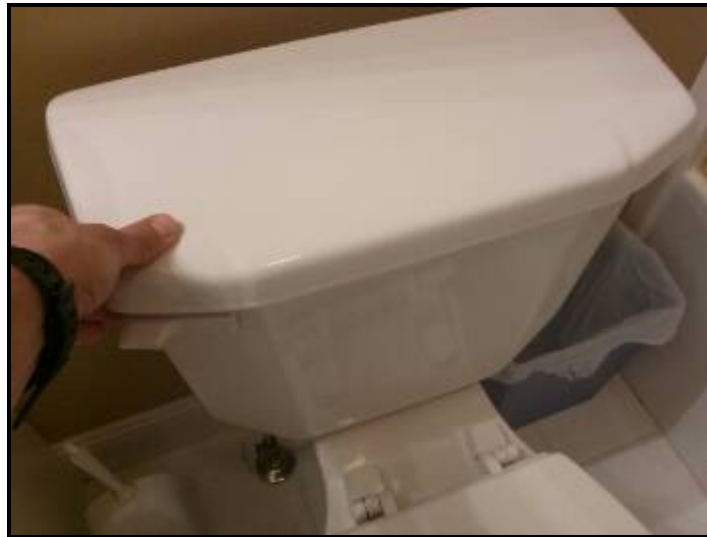
12. Toilets

- Tank loose and may need resecured upstairs south

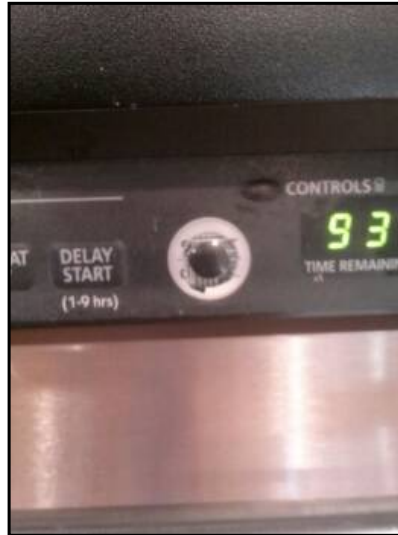
1. Dishwasher

Observations:
 • Damage noted at start button

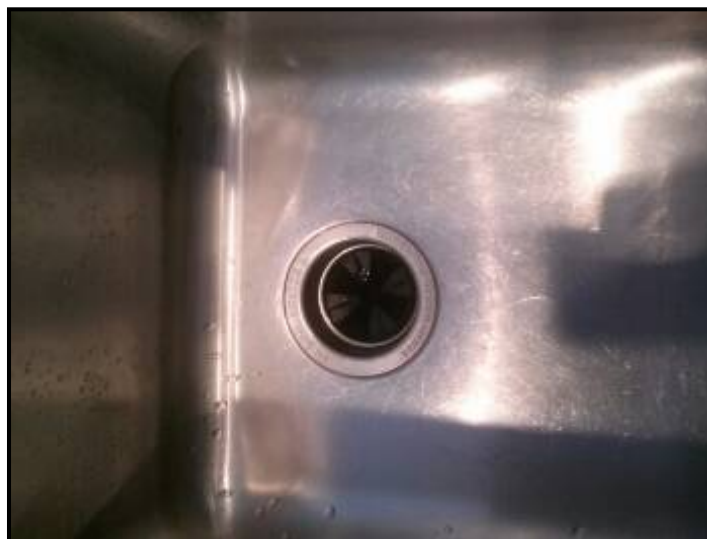
3. Garbage Disposal

Observations:
 • The unit makes irregular noise. This may be a foreign object stuck in the disposal.

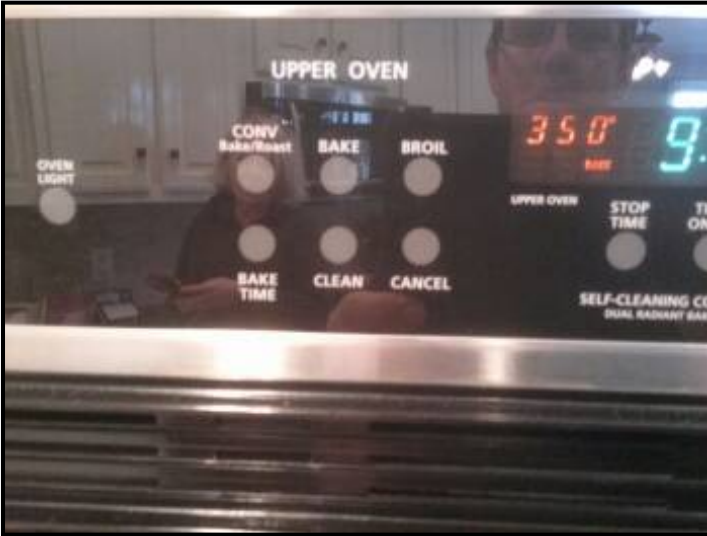
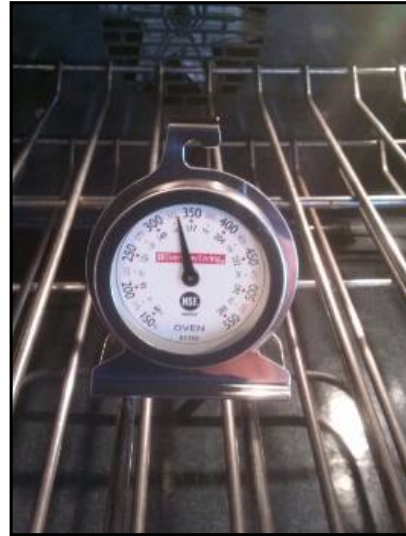
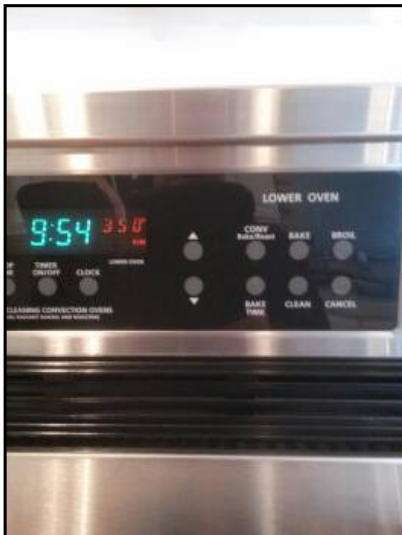
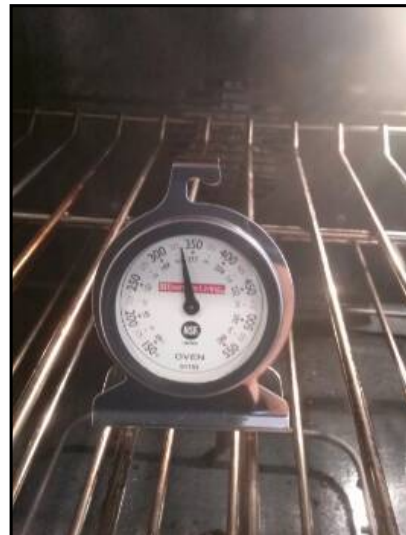
6. Oven & Range

Observations:
 • Upper oven temperature measured 325 at the 350 degree setting. Lower oven tested at 330 at the 350 degree setting.

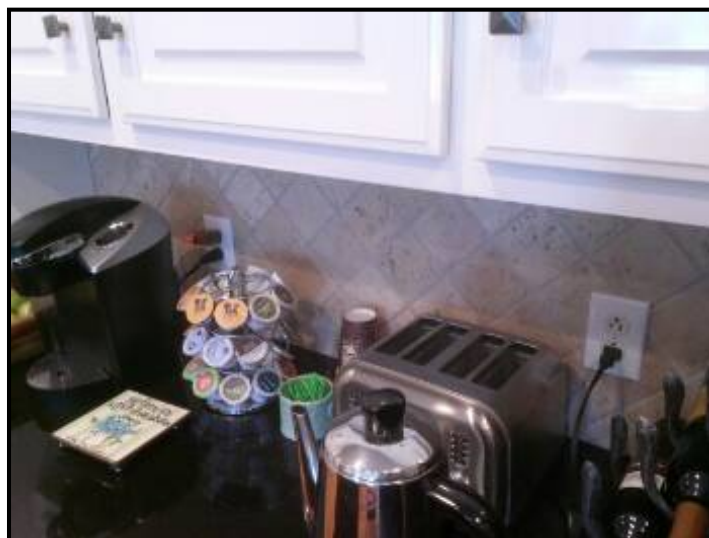
17. GFCI

- GFCI, lights & fans on same circuit.
- GFCI did not respond to test at south side, suggest replacing for safety.

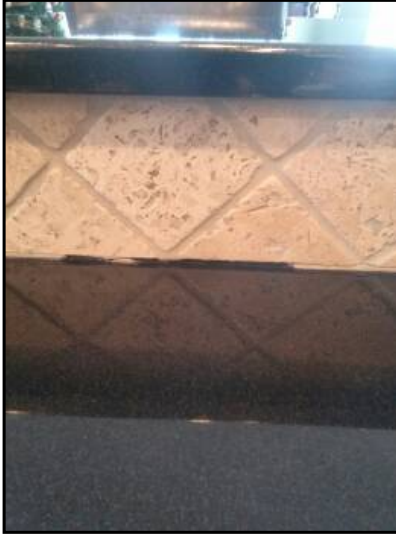
18. Wall Condition

- There are areas still under construction. These areas are not tested.
- Some grout was deteriorated in area of dishwasher

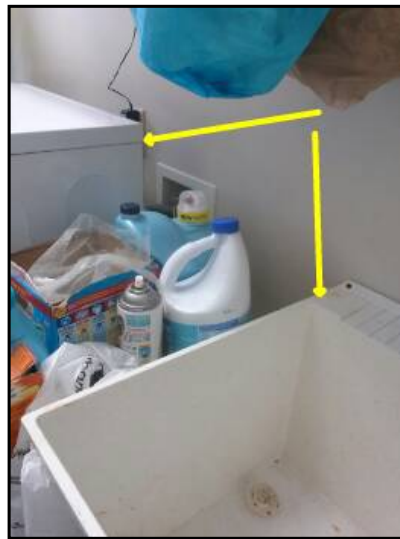
4. GFCI

• No GFCI protection present, suggest installing GFCI protected receptacles for safety.

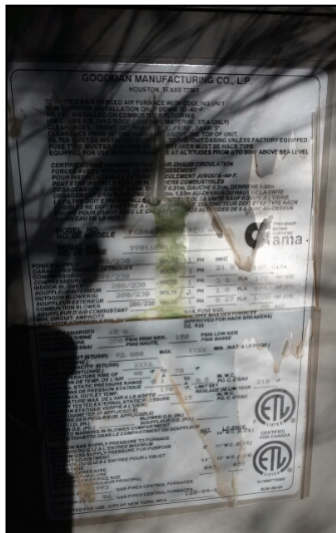
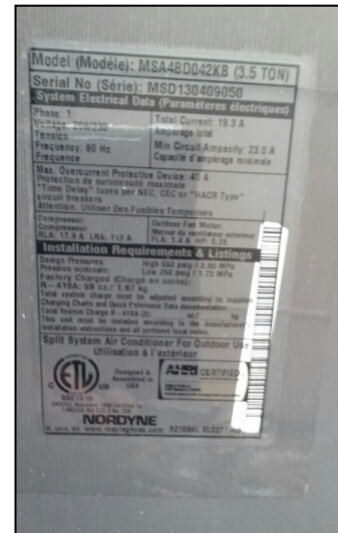
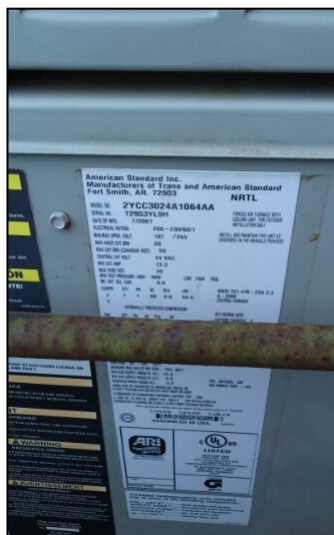
1. Equipment Description

- Typical rated lifespan for these type units is 12-15 years.
- 1999 unit is well past its rated lifespan. Inspector recommends further evaluation of this unit by an HVAC contractor.

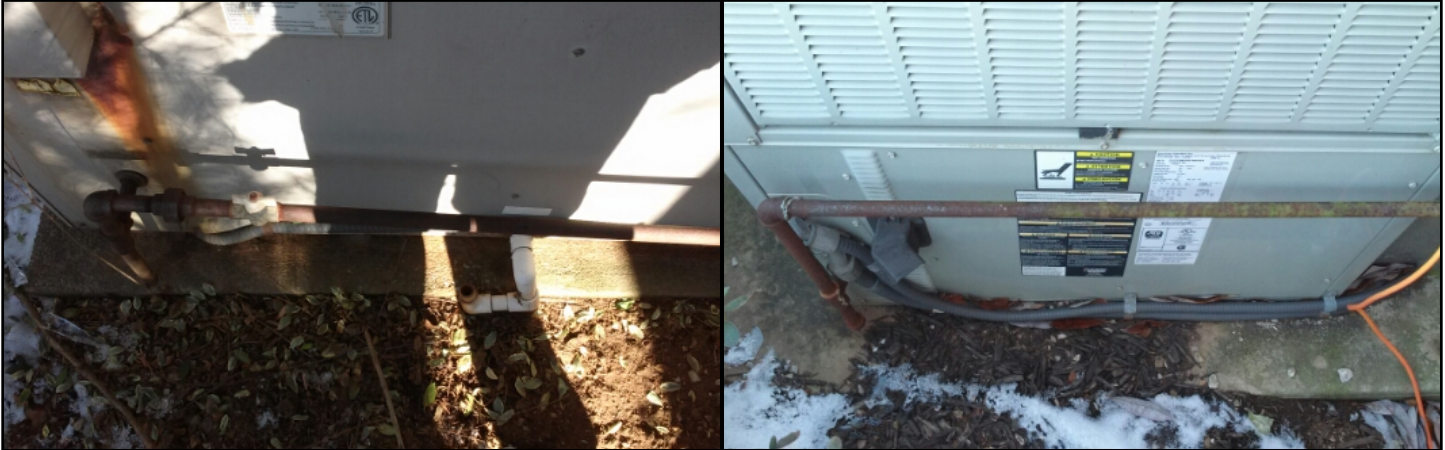
6. Gas Valves

- Gas line to the furnace was corroded. Line should be over sprayed to prevent further corrosion and eventual leaks from forming.

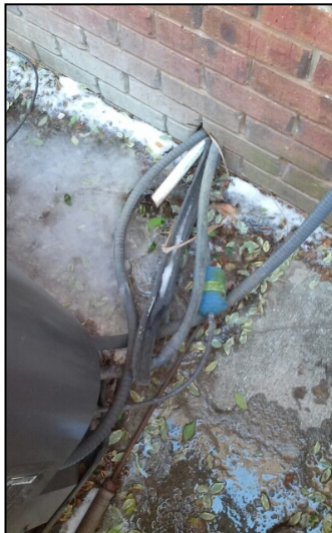
8. AC Compress Condition

- Appeared functional at the time of inspection.
- Cooling unit could not be tested as the external temperature was below 60 degrees.
- The insulation is missing or damaged at exterior refrigerant line.

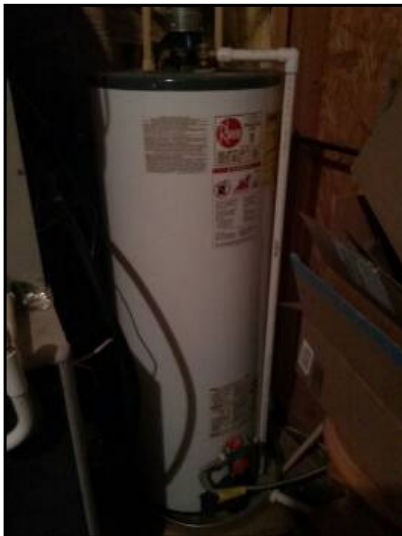
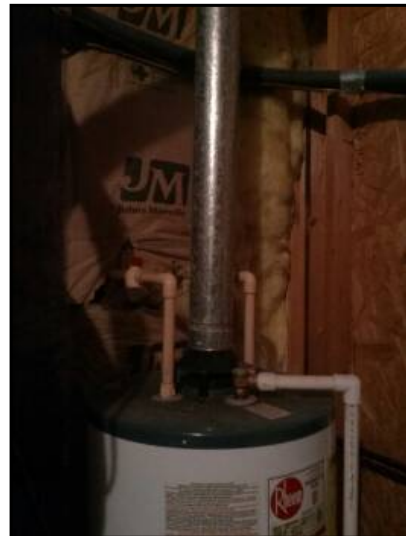
5. Water Heater Condition

Heater Type: Gas
 Location: The heater is located in the attic.
 Observations:
 • Modern standards would require an **expansion tank** be installed.

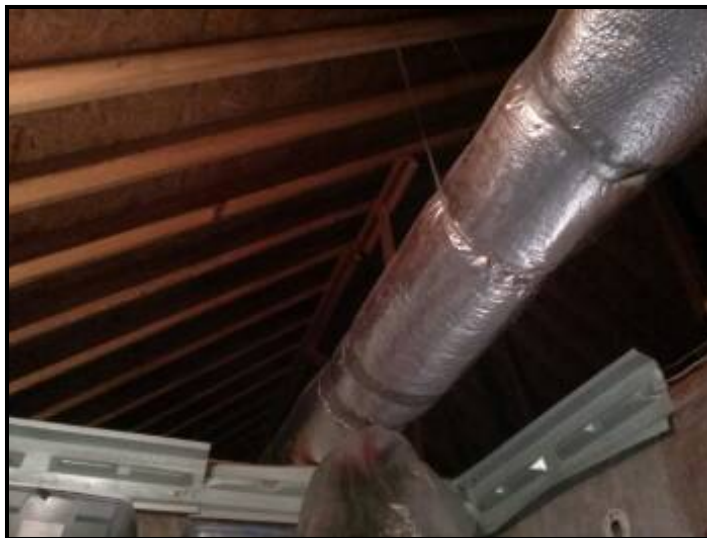
1. Access

- Upstairs Hall.
- No Visible Access to upper portion of attic.

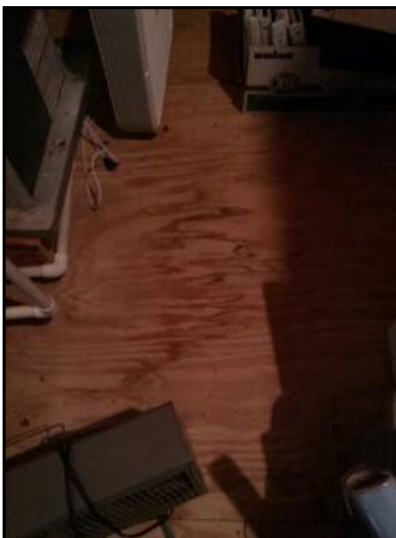
2. Structure

- Moisture stains at flooring in area of furnace tested damp at time of inspection.

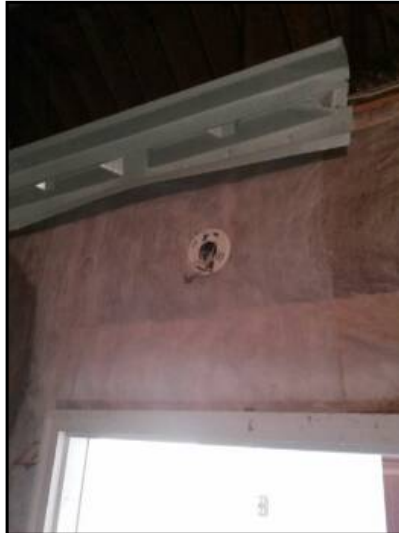
6. Electrical

- Missing smoke detector

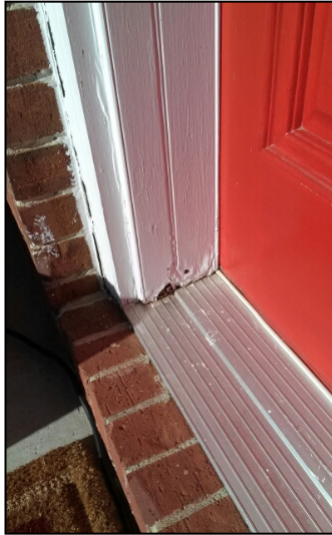
1. Doors

- Left side casing at the front entry door was decayed at the base.

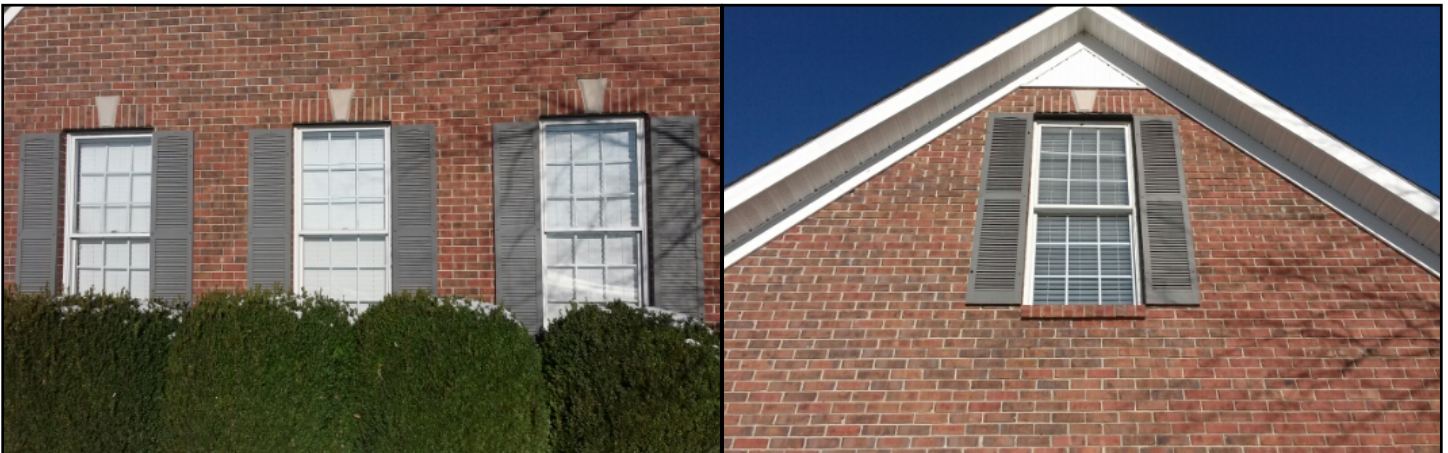
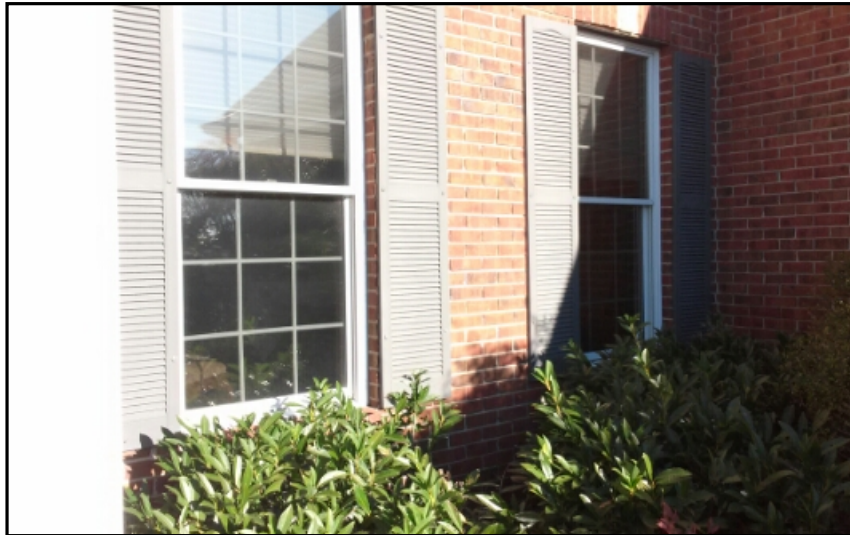
2. Window Condition

- All window screens were missing.

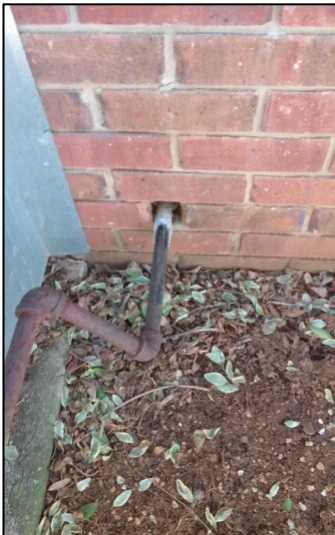
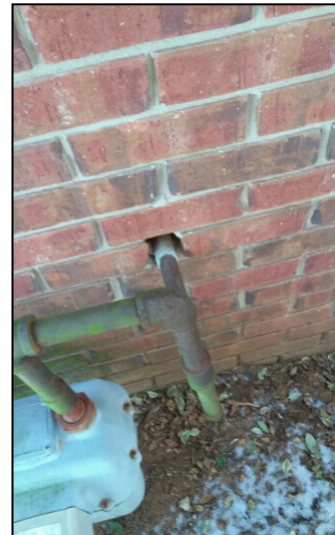
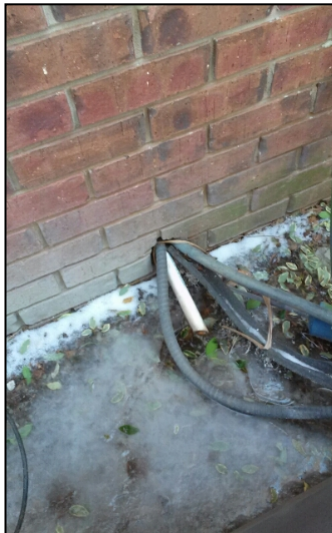
3. Siding Condition

- Gas and a/c line penetrations of the exterior wall should be sealed to prevent moisture intrusion.

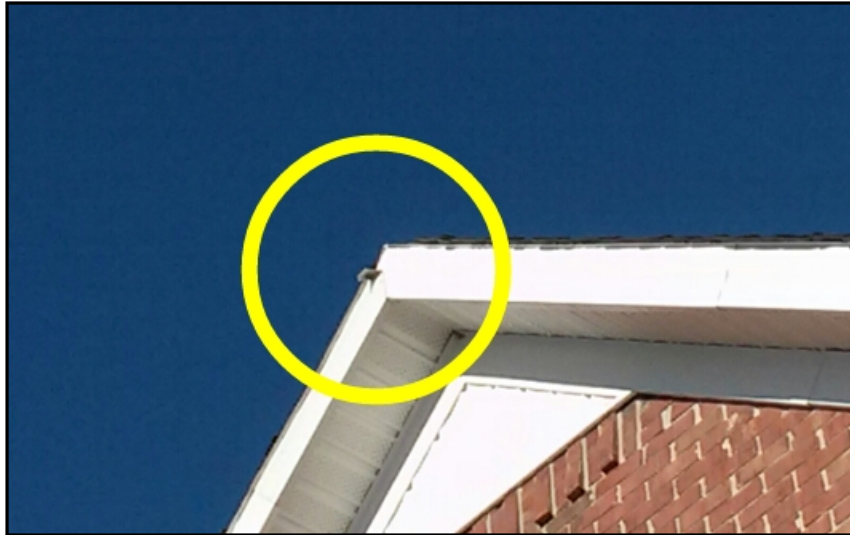
4. Eaves & Fascia

- Aluminum trim piece at the east peak was bent away from the fascia.

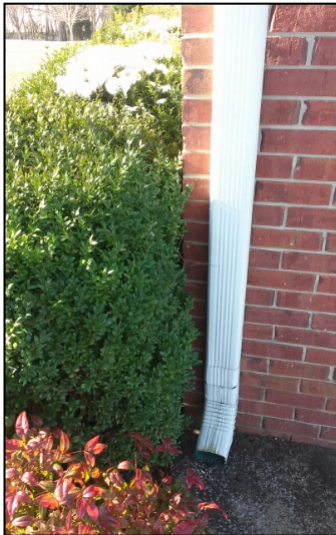
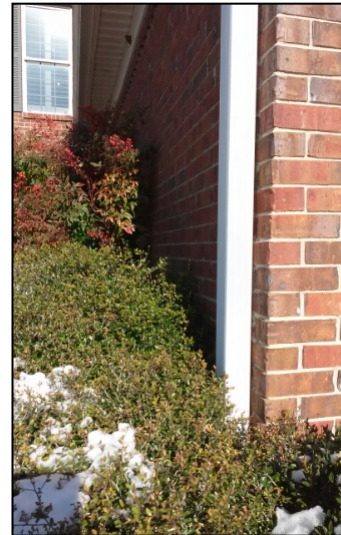
3. Vegetation Observations

- Prune or remove any plants that are in contact or proximity to home to eliminate pathways of wood destroying insects.

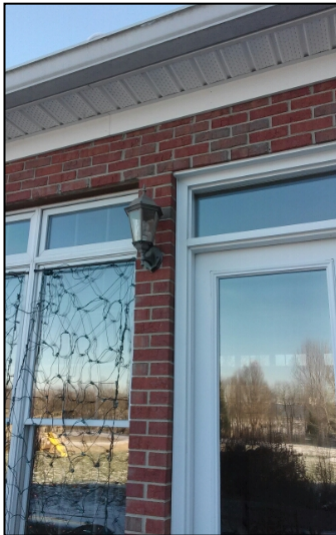
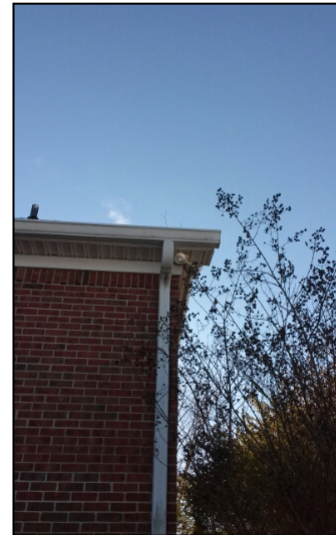
7. Grounds Electrical

- Left side back patio light fixture was not functioning.
- Southwest corner security lights were not functioning.

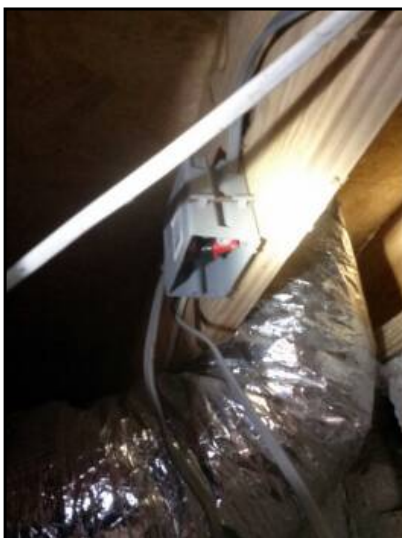
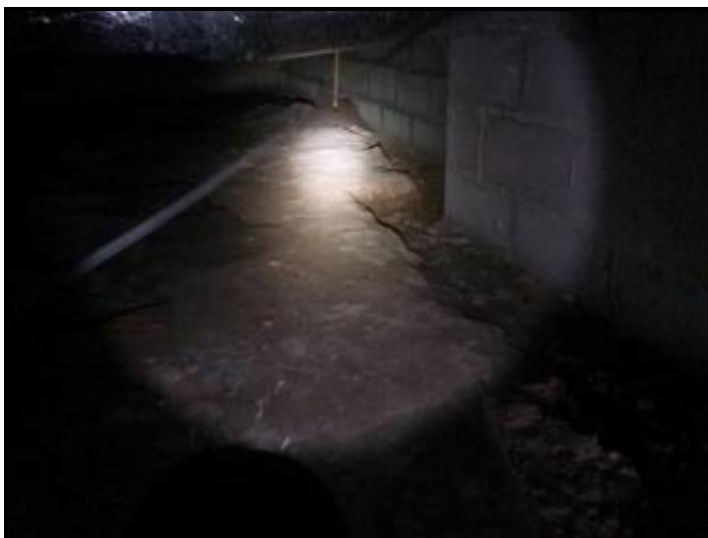
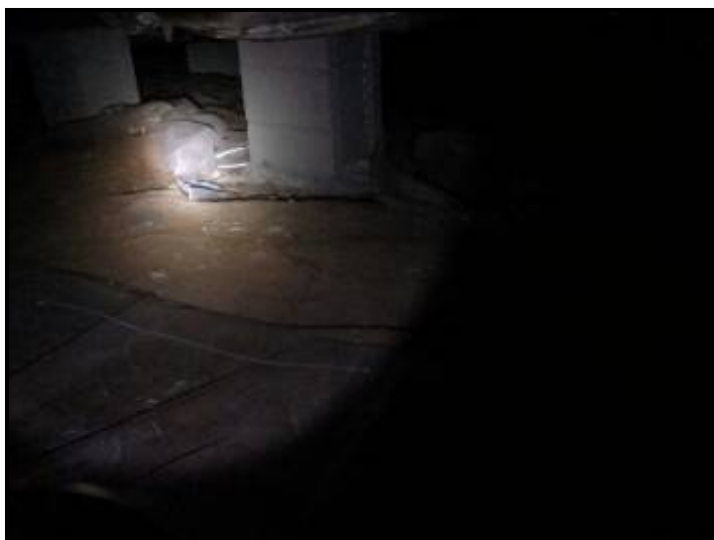
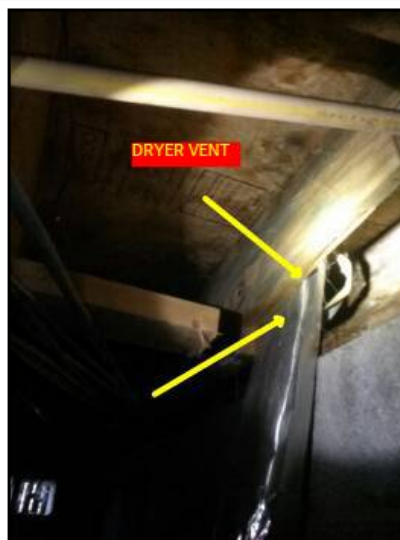
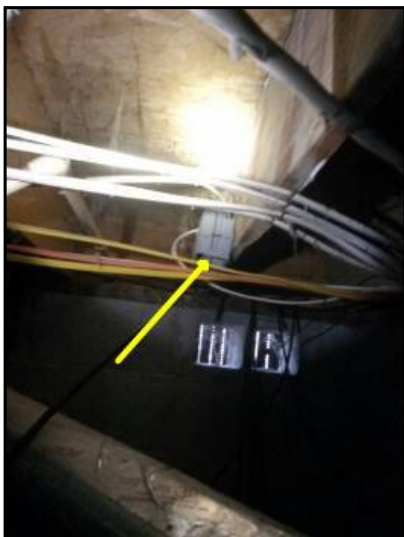
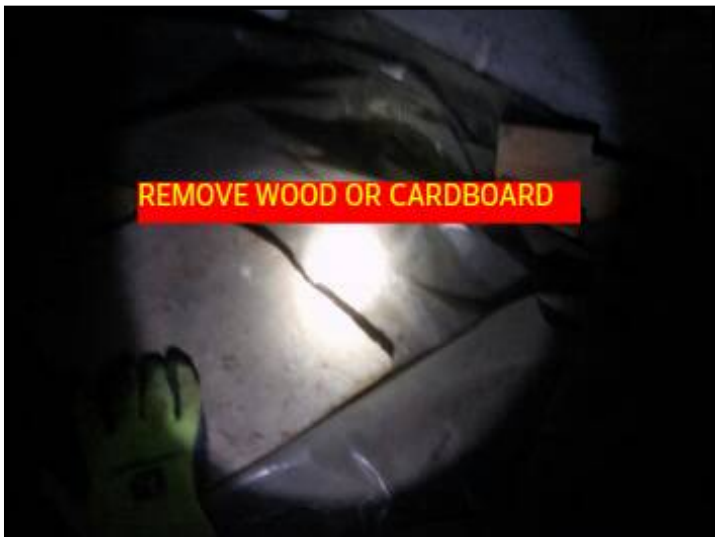
1. Crawlspace

- Loose wood and cardboard should be removed from the crawlspace to prevent termite infestation.
- Open junction boxes were noted in southeastern and northeastern crawl
- Moisture barrier was missing from some areas of the crawlspace.
- Dryer vent was pinched closed in the area of the laundry room floor joists. This will prevent adequate propulsion of lint and humidifier air.

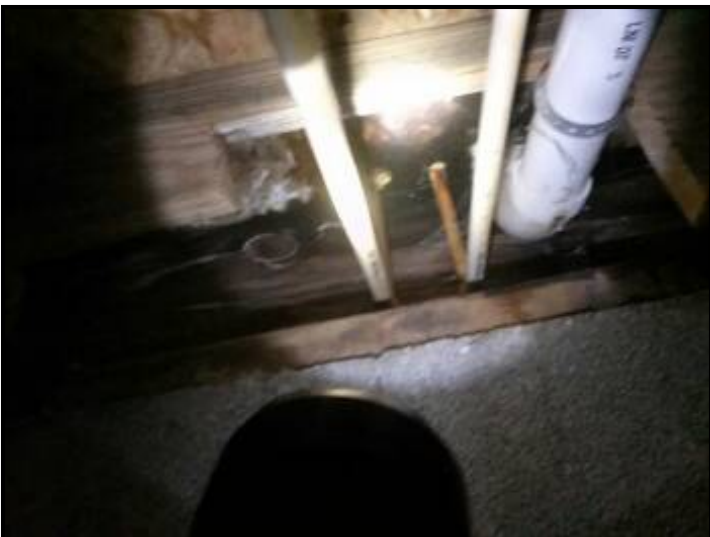
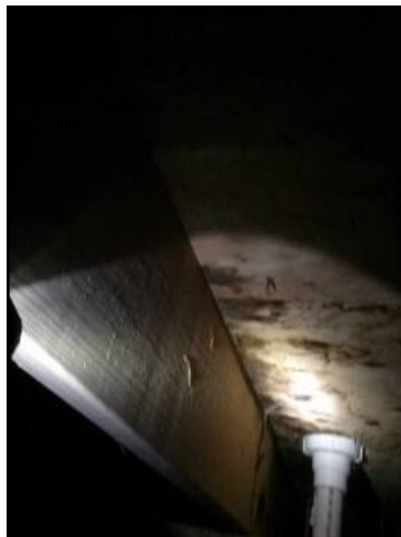
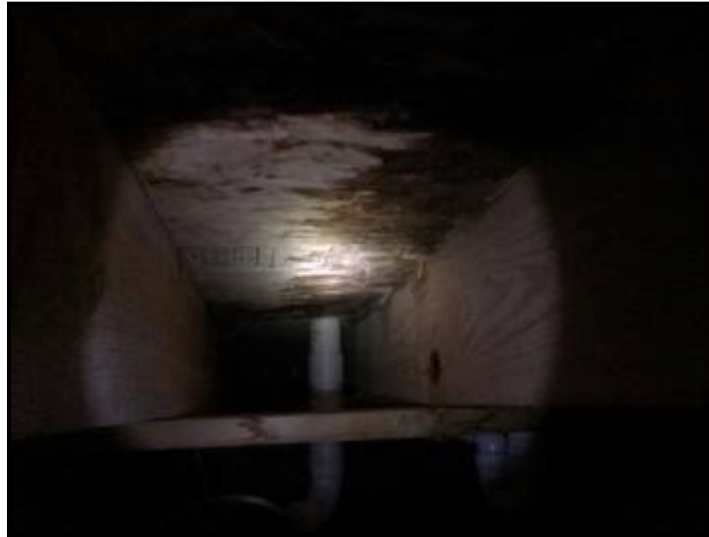
4. Plumbing

- Evidence of leakage detected in area of laundry room and master bathroom and requires review and repair by a qualified contractor.

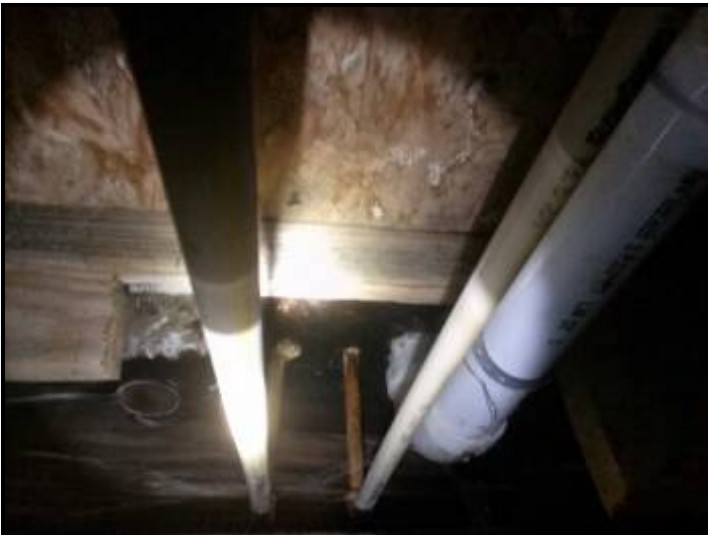
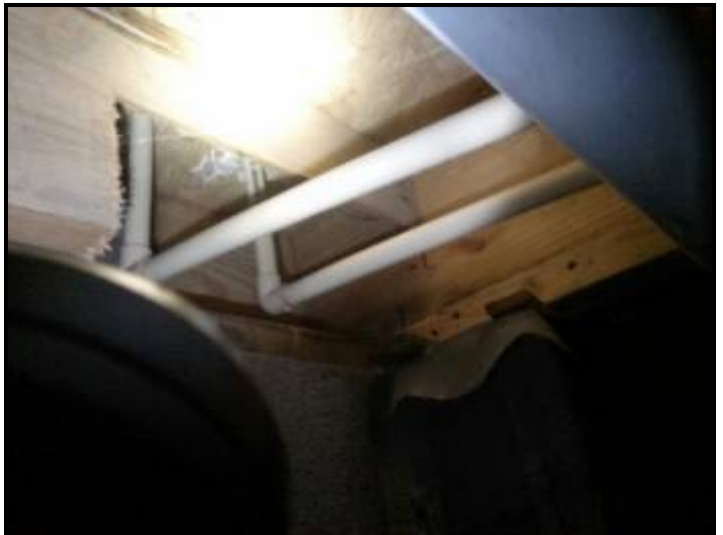
7. Framing

Page 43 Item: 7	Framing	<ul style="list-style-type: none"> • Improper cutting/over notching of floor joist noted in area of laundry room in northeast crawl. Recommend review and repair by a qualified contractor.

- Improper cutting/over notching of floor joist noted in area of laundry room in northeast crawl. Recommend review and repair by a qualified contractor.
