Tennessee Valley Property Inspections

Property Inspection Report

1234 Main Street, Anytown, TN
Inspection prepared for: Billy Bob & Eula May Jones
Date of Inspection: 1/9/2017 Time: 0900 Size: 4900sf
Weather: 30 degrees. Sunny
Home faces the east
Also inspected by Matthew Fox, Lic #1576

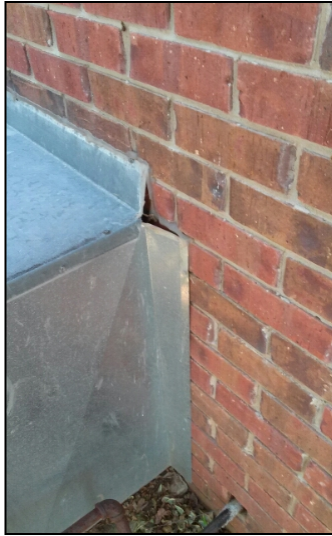
• Plenum for the main package unit needed to be attached and sealed to the exterior wall.

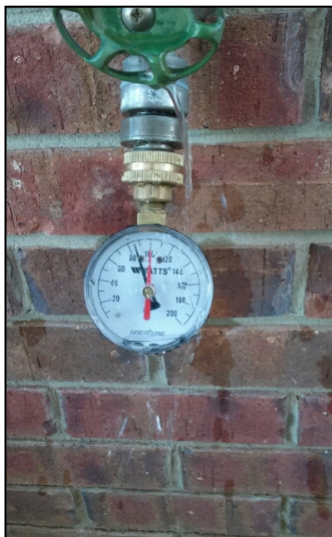
- High pressure.
- 85
- Normal range for residential is 45 - 75.
